Fracture Strength of Three-Unit Implant Supported Fixed Partial Dentures with Excessive Crown Height Fabricated from Different Materials

Objectives: Fracture strength is an important factor influencing the clinical long-term success of implant-supported prostheses especially in high stress situations like excessive crown height space (CHS). The purpose of this study was to compare the fracture strength of implant-supported fixed partial dentures (FPDs) with excessive crown height, fabricated from three different materials.

Journal of Dentistry, Tehran University of Medical Sciences, Tehran, Iran (2016; Vol. 13, No. 6)

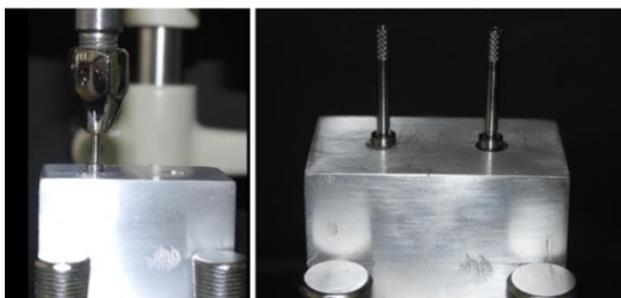
Fig. 1: Mounted implants parallel to each other using a surveyor

Two implants, 12mm in height and 4.5mm in diameter (Implantium; Dentium, Seoul, South Korea), were inserted in an aluminum reference model using auto-polymerizing acrylic resin (Technovits 4000; Heraeus Kulzer GmbH & Co., Wehrheim, Germany). The distance between the centers of the implants was 18mm. This distance was approximately equal to the distance between the centers of the mandibular second premolar and the second molar. A dental surveyor (J.M. Ney Co., Bloomfield, CT) was used to control the vertical and axial orientation of inserted implants (Fig. 1). Two straight abutments (Implantium; Dentium, Seoul, South Korea) with 5.5mm height and 4.5 and 5.5mm platform diameter were adapted over each implant and tightened to 35Ncm according to the manufacturer's instructions. All samples were directly fabricated on this reference model.

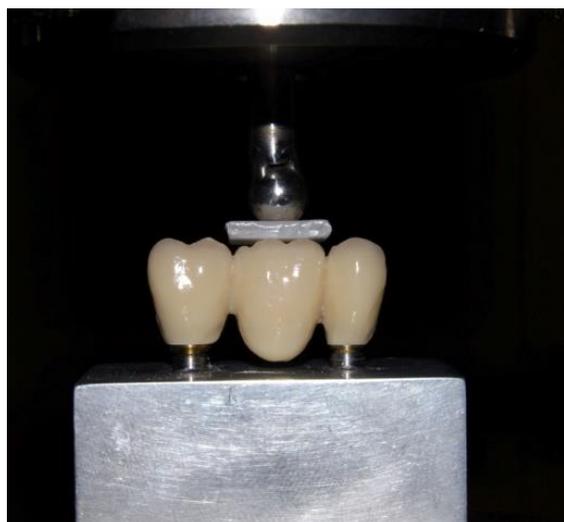
Fig. 2: Position of stainless steel ball and Teflon disk at loading point

Each framework was placed on the abutments and then the assembly was mounted on a universal testing machine (Z050; Zwick Roell, Ulm, Germany). Axial compressive load was applied to the center of the occlusal surface of pontic using a stainless steel ball (diameter = 8mm) at a constant crosshead speed of 0.5 mm/minute. To prevent any contact damage and to provide homogeneous load distribution on the pontic, a 2mm thick Teflon disk with length and width of 10 \times 10mm, was placed between the stainless steel ball and the occlusal surface of the pontic (Fig. 2). Loading was continued until catastrophic fracture of the samples occurred. The data of failure load were recorded using computer software (Zwick's test Xpert v2; Zwick, Ulm, Germany), and registered in Newtons (N).
